SUBJECT: Gudaitis Lake Dam (MO 30702); Phase I Inspection Report

GUDAITIS LAKE DAM
Washington County, Missouri
Missouri Inventory No. 30702

Phase I Inspection Report
National Dam Safety Program

Gudaitis Lake Dam
Missouri
Washington
Unnamed Tributary of Clear Creek
18 July 1980

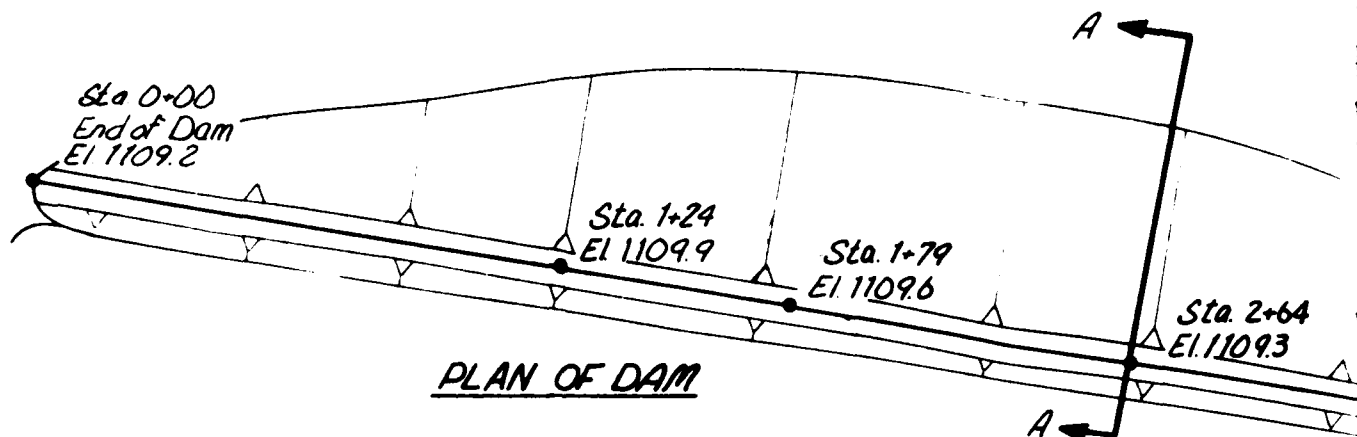
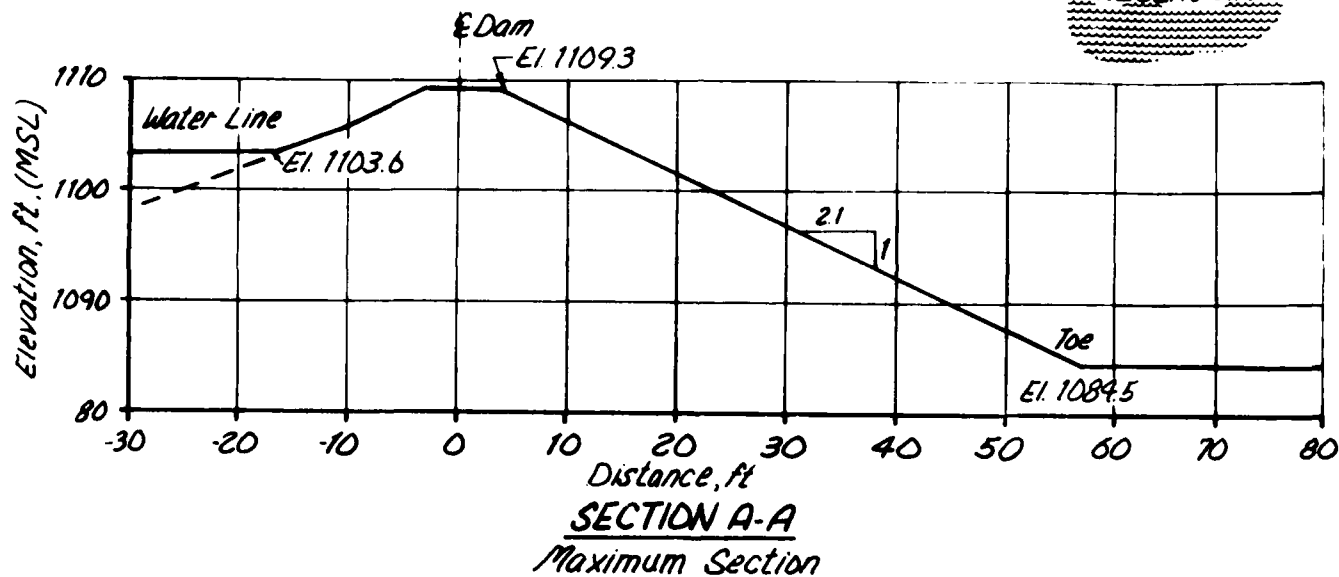
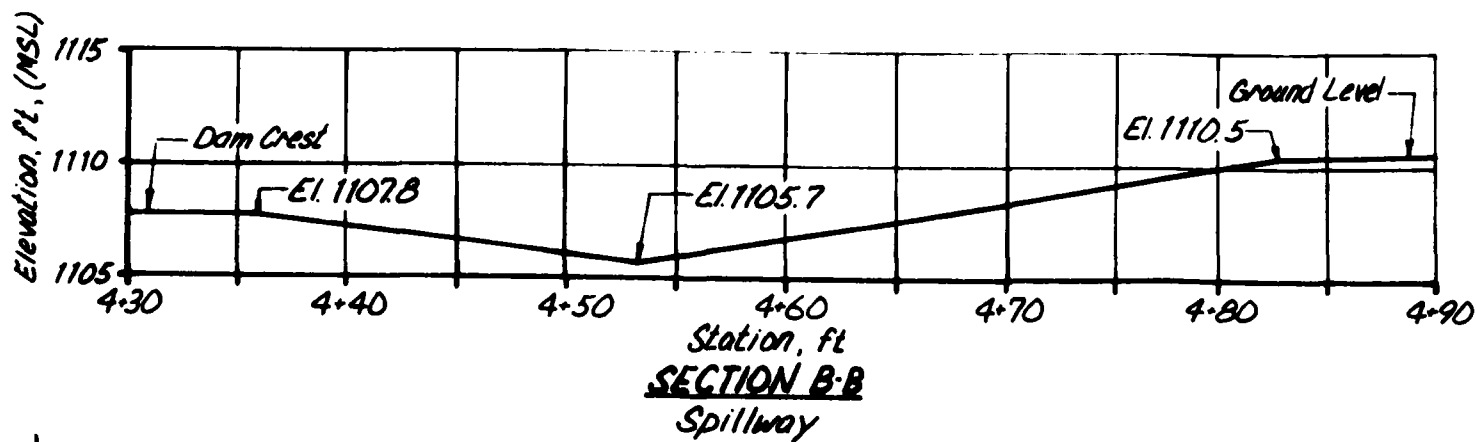
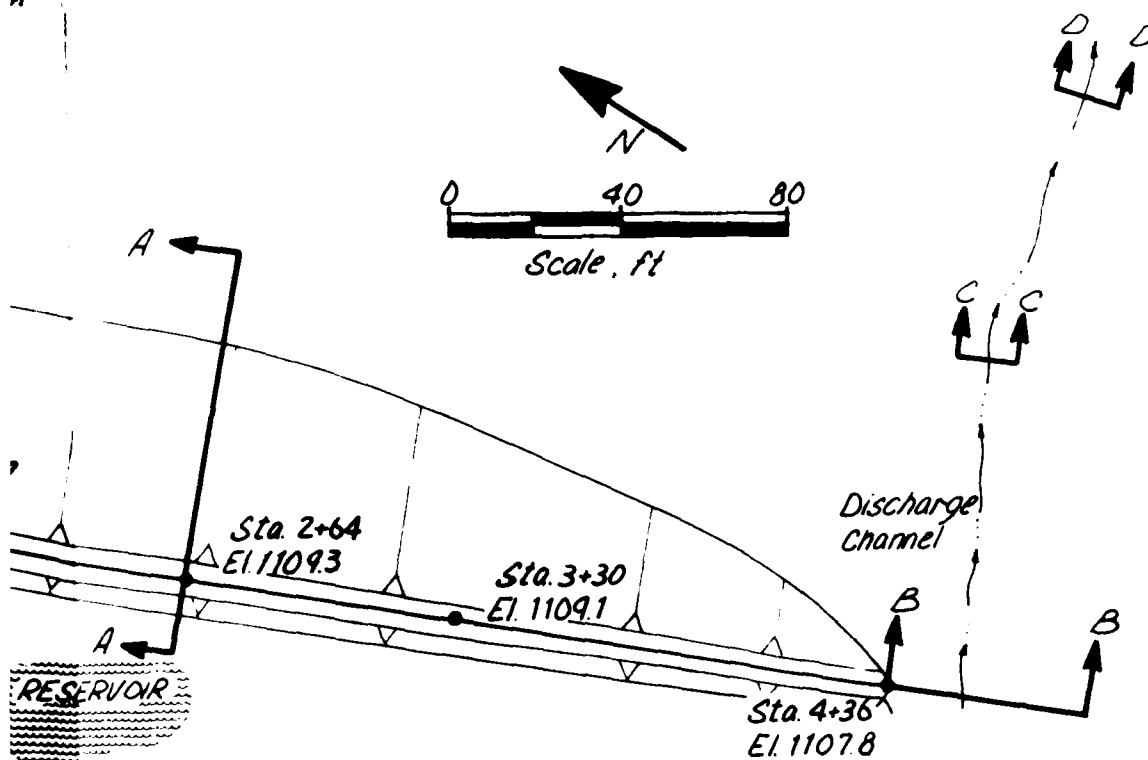
Fig. 3-A

- c. Appurtenant structures. The "V" notch, grass-lined spillway is cut into the southeast abutment and the hillside, running slightly downslope (Photo 3 and Fig A-1). Mr Gudaitis reported that the spillway carries water during moderate rains ("moderate" being undefined). There is no evidence of prior instability or significant erosion in the spillway. The spillway area would be moderately erodible if the downhill side of the discharge channel was overtopped. Such an event would increase the flow velocity and could cause headward channel erosion. If the spillway and discharge channel were eroded, floodwaters would run near the downstream face and along the toe of the dam.

PLAN AND SECTIONS OF DAM AND SPILLWAY

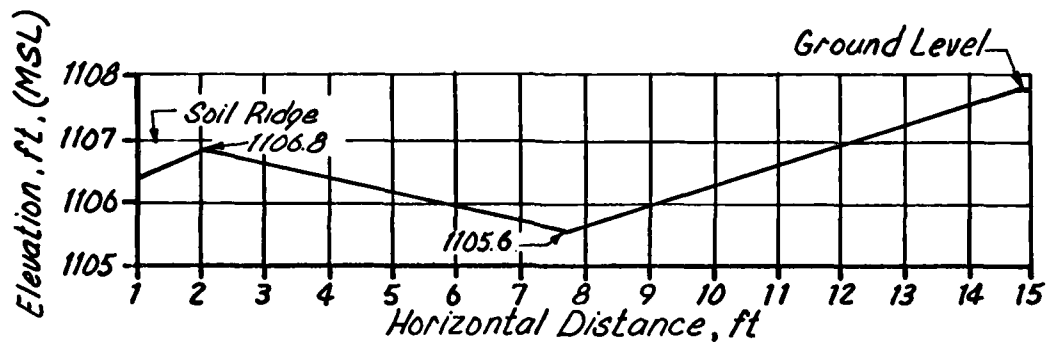
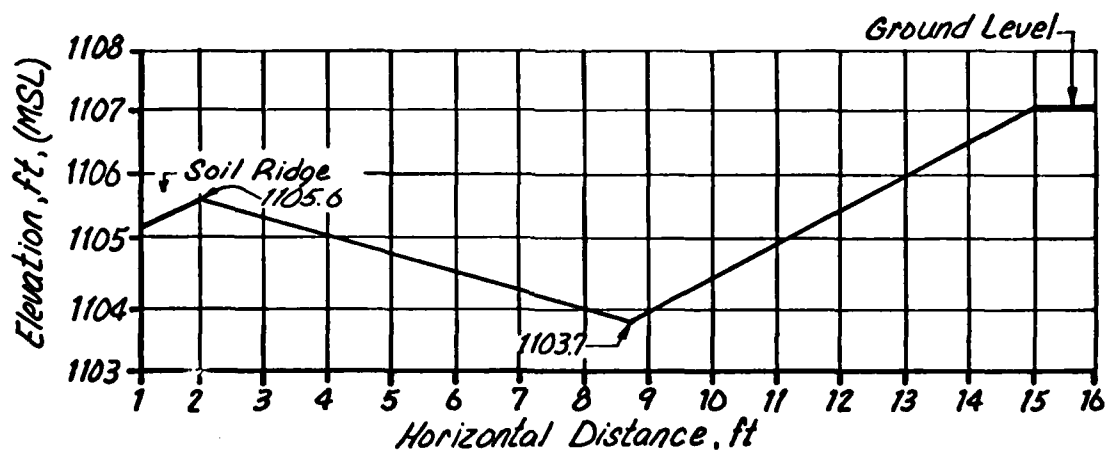
SECTIONS OF DISCHARGE CHANNEL	
GUDAITIS LAKE DAM	
MO 30702	Fig. 3B

3. Spillway. The spillway is located at the southeast end of the dam (Photo 2). It is excavated in the natural ground and has little vegetative growth (Photo 3). The open channel spillway carries flow into the downstream discharge channel. The spillway discharge channel lies on the slope of the southeastern valley sidewall. Therefore, there is a possibility of flow spilling out of the discharge channel and eroding the bank of the channel. This may represent a potential danger to the downstream toe of the dam.

SECTION C-C
Discharge Channel

SECTION D-D
Discharge Channel
